Revision 4 of Galapagos LSPS Response Corrective Action Plan

1. Galapagos Layout

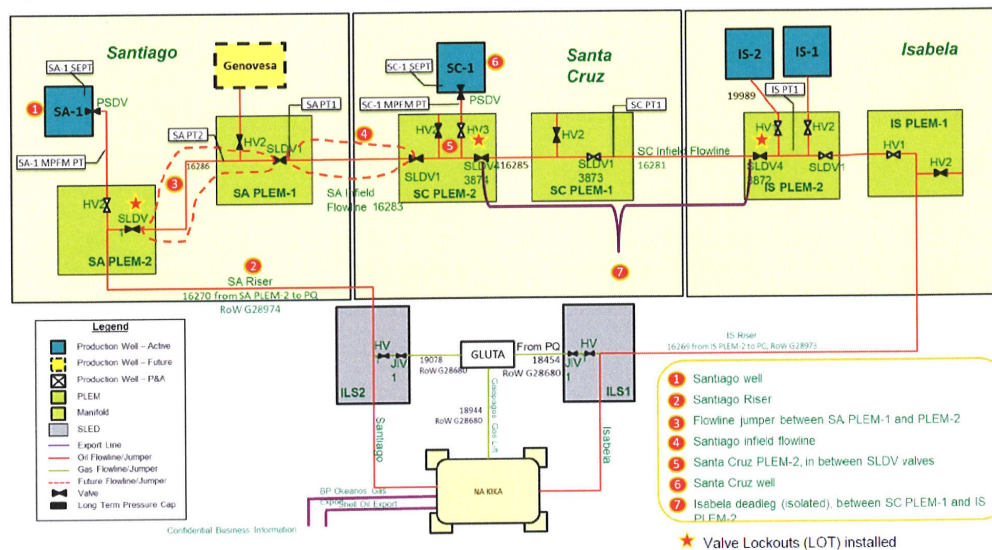
The Galapagos loop subsea production system (LSPS) is in the Mississippi Canyon Area (MC) Blocks 561 and 519, at water depths between 6,300ft and 6,550ft. The LSPS ties back to the host facility at Na Kika. Figure 1 illustrates a schematic of the field.
